Drainage Work Order Request For Repair

Hardin County

Work Order # 91

Landowner located in the NE¼ of Section 24, Township 88 North, Range 20 West reported a tile blowout. Upon talking with District Trustees, they authorized televising while tile was open for repairs. Excavated at blowout and found broken and egged shaped 22" VCP main tile.

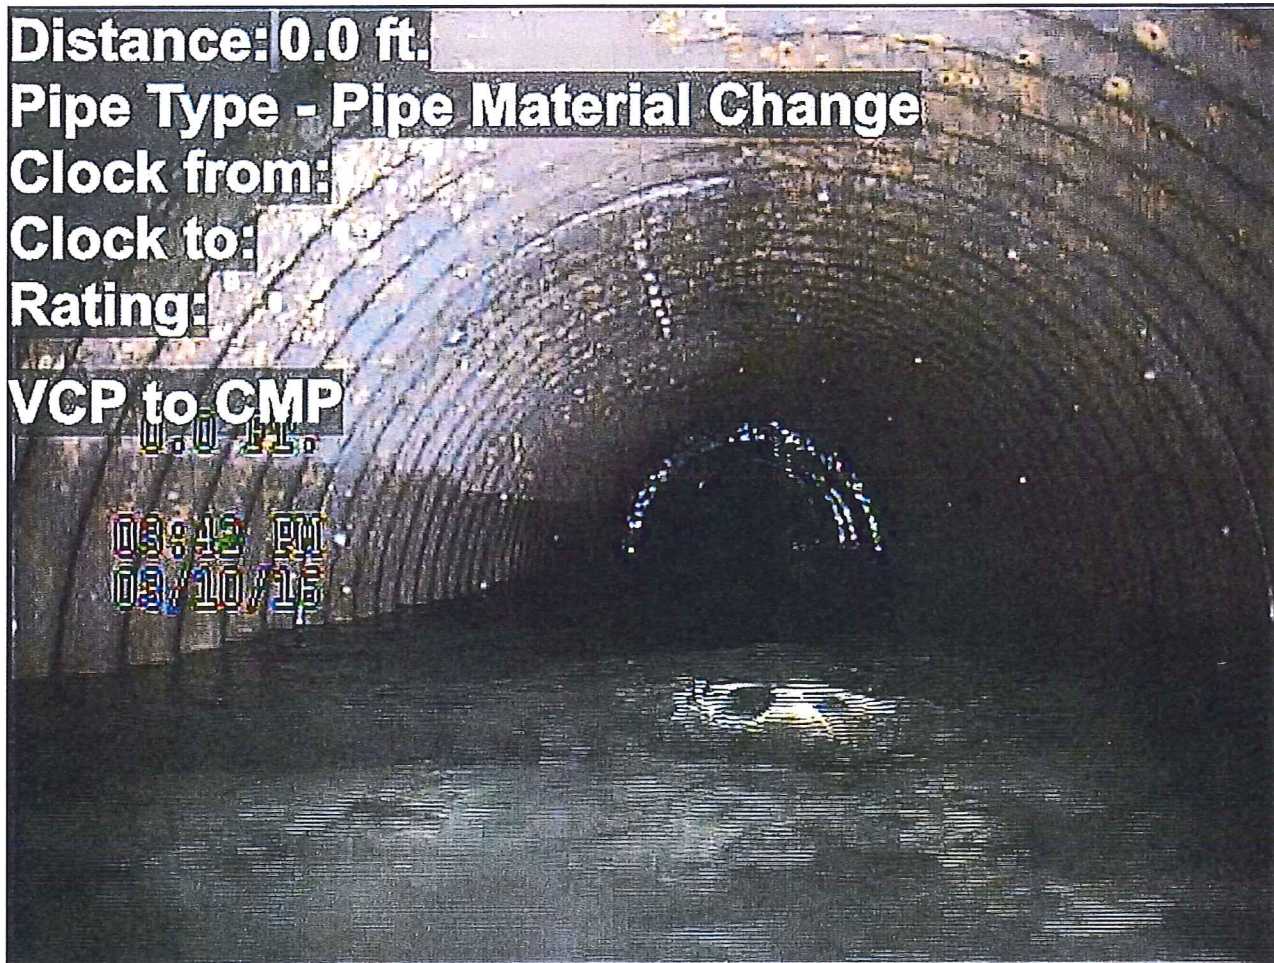
Pipe Type - Pipe Material Change

VCP to CMP
